Test report no.: 203241/19

Order: Testing of Fastness to weathering (colour fastness) and Resistance to weathering (cross-cut test) after artificial weathering according to Technical appendix, section A, CAT.5 to RAL-GZ 716 (issue July 2018) on colour-coated window profiles made of PVC-U.

Artificial weathering according to DIN EN 513: 2019-03, procedure 1 (simulation of a moderate climate zone M) up to a total irradiation dose equivalent of 8 GJ/m² in the wave length range of 300 nm to 800 nm.

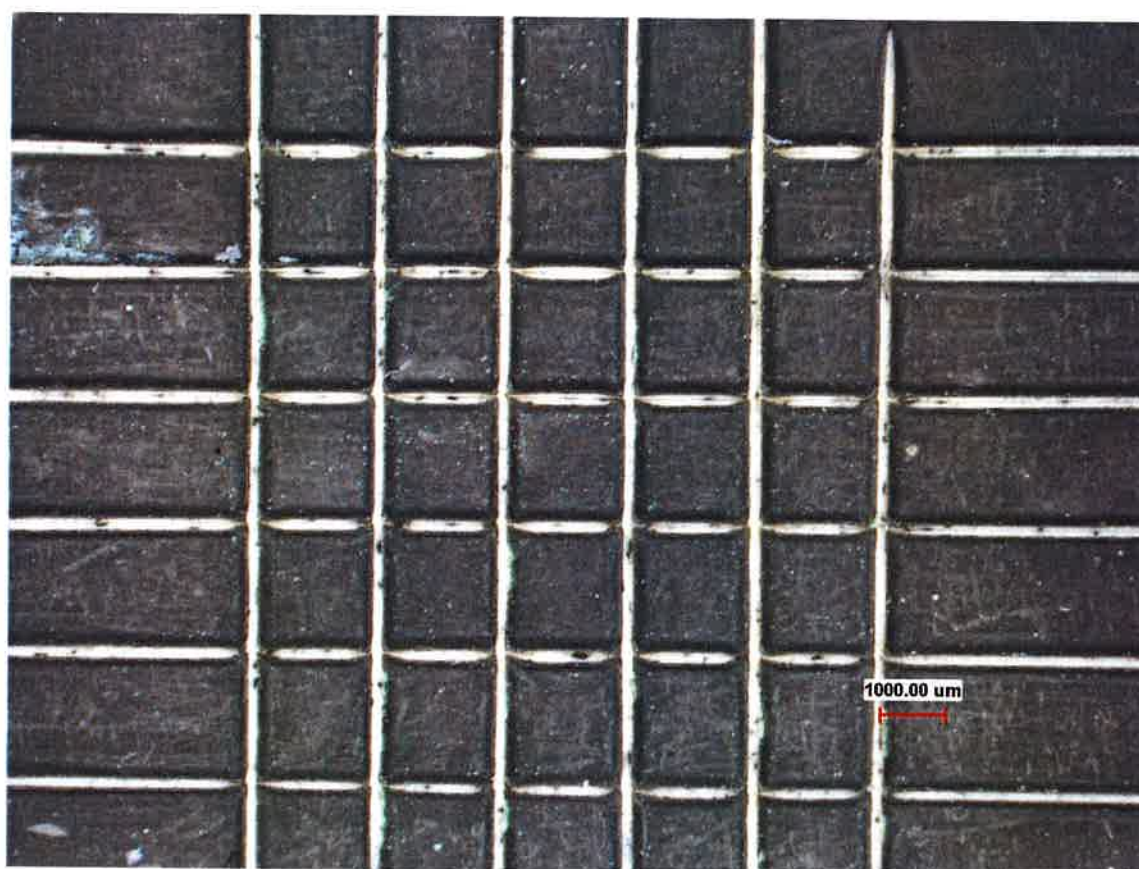
Detailed view 20x magnification after 8 GJ/m²

Cross-cut Grade		
Sample no. 1: Alpocryl LE / RAL 6009		
before artificial weathering	after artificial weathering	
	4 GJ/m ²	8 GJ/m ²
Gt 0 (ISO 2409: 2013 – 1c – 0)	Gt 0 (ISO 2409: 2013 – 1c – 0)	Gt 0 (ISO 2409: 2013 – 1c – 0)
Cross-cut grade 0 was determined on zero sample (delivery condition) as well as on artificially weathered test specimen. The cut edges were completely smooth, none of the squares of the grid had chipped off.

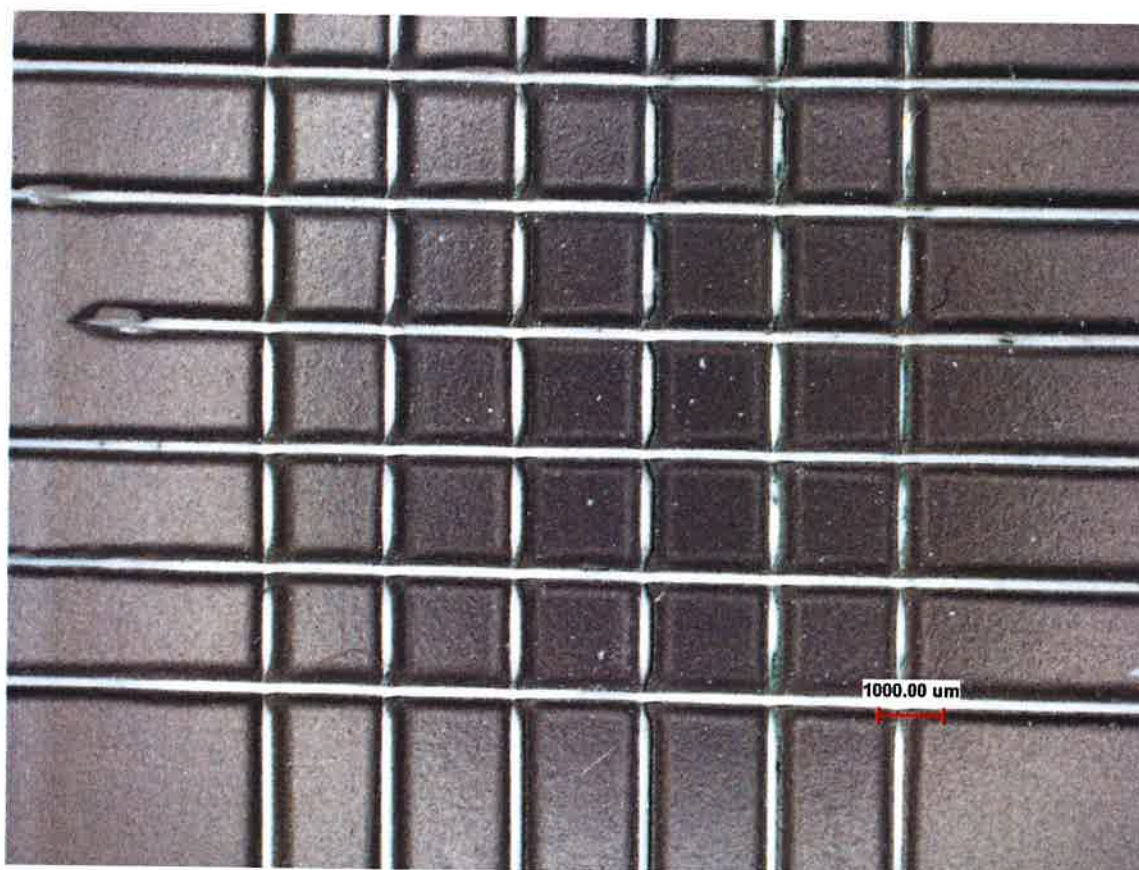
Detailed view 20x magnification after 8 GJ/m²

Cross-cut Grade		
Sample no. 2: Hydropur 2K 7515 / RAL 6009		
before artificial weathering	after artificial weathering	
	4 GJ/m ²	8 GJ/m ²
Gt 0 (ISO 2409: 2013 – 1c – 0)	Gt 0 (ISO 2409: 2013 – 1c – 0)	Gt 0 (ISO 2409: 2013 – 1c – 0)
Cross-cut grade 0 was determined on zero sample (delivery condition) as well as on artificially weathered test specimen. The cut edges were completely smooth, none of the squares of the grid had chipped off.

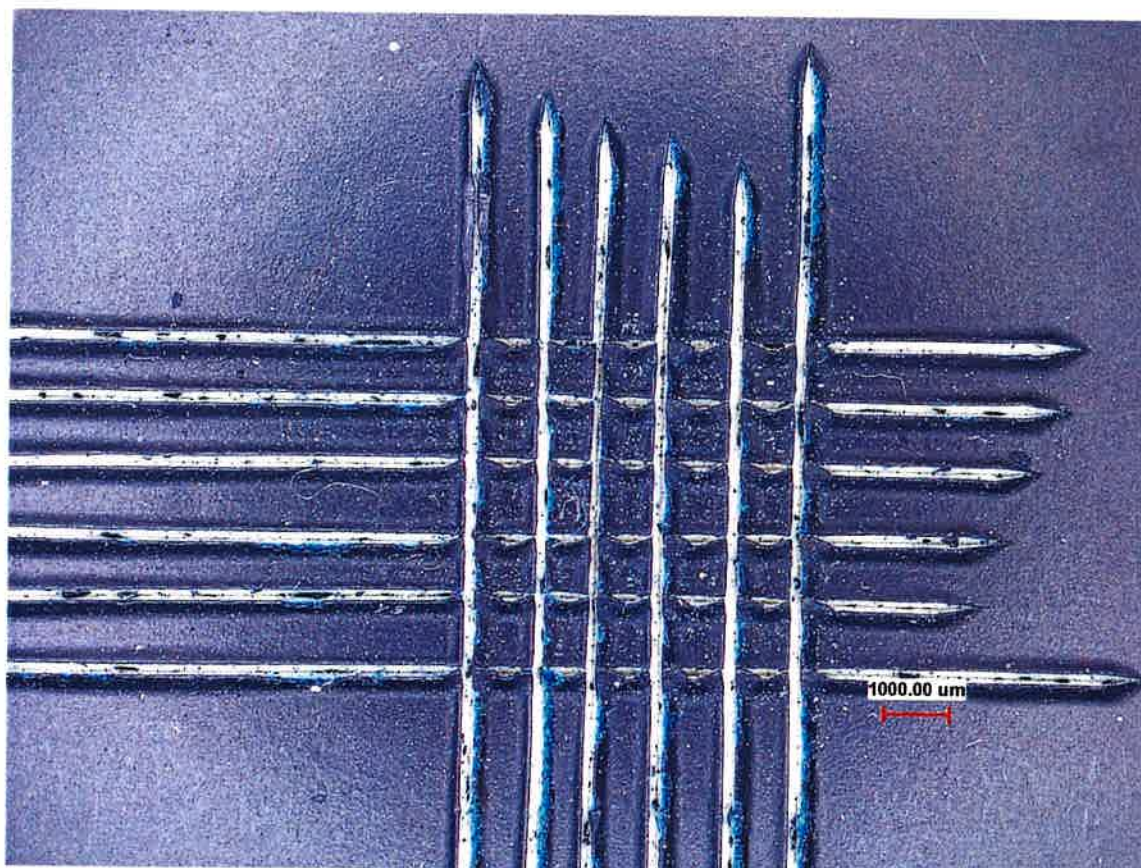
Detailed view 20x magnification after 8 GJ/m²

Cross-cut Grade		
Sample no. 3: Alpocryl LE / RAL 5011		
before artificial weathering	after artificial weathering	
	4 GJ/m ²	8 GJ/m ²
Gt 0 (ISO 2409: 2013 – 1c – 0)	Gt 0 (ISO 2409: 2013 – 1c – 0)	Gt 0 (ISO 2409: 2013 – 1c – 0)
Cross-cut grade 0 was determined on zero sample (delivery condition) as well as on artificially weathered test specimen. The cut edges were completely smooth, none of the squares of the grid had chipped off.

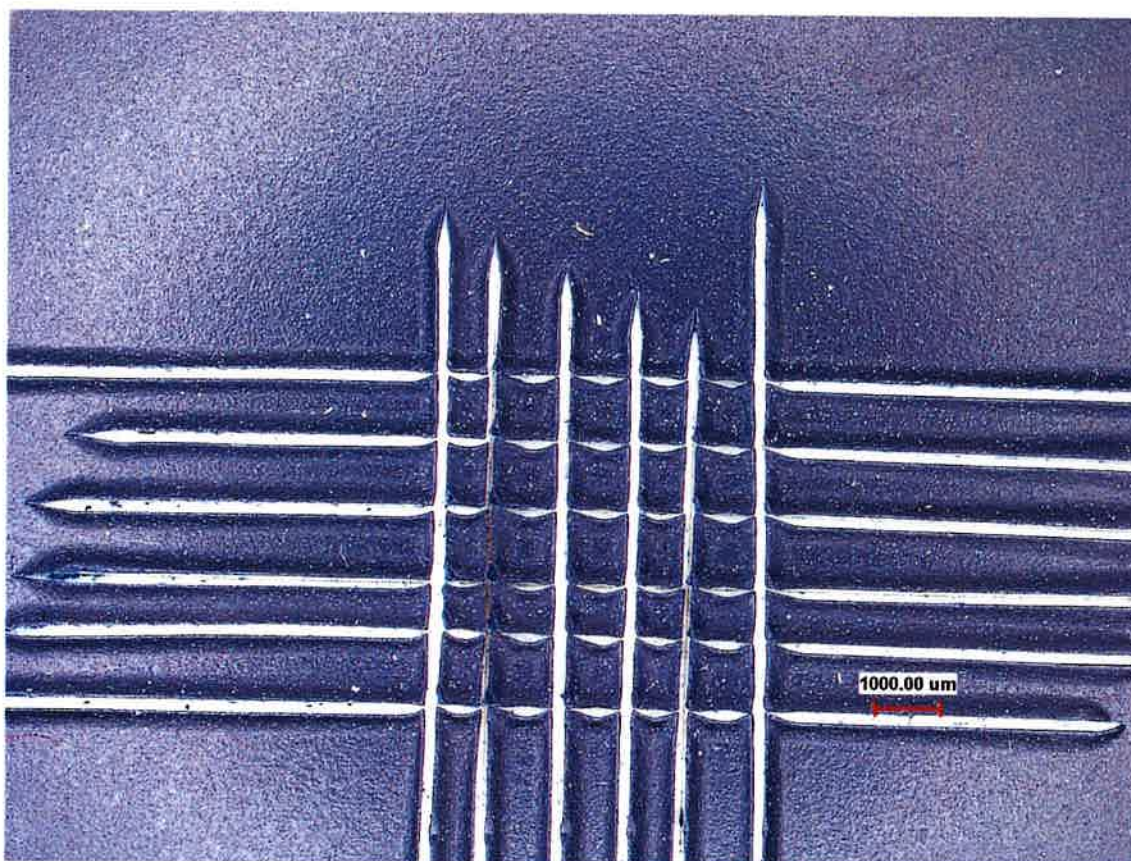
Detailed view 20x magnification after 8 GJ/m²

Cross-cut Grade		
Sample no. 4: Hydropur 2K 7515 / RAL 5011		
before artificial weathering	after artificial weathering	
	4 GJ/m ²	8 GJ/m ²
Gt 0 (ISO 2409: 2013 – 1c – 0)	Gt 0 (ISO 2409: 2013 – 1c – 0)	Gt 0 (ISO 2409: 2013 – 1c – 0)
Cross-cut grade 0 was determined on zero sample (delivery condition) as well as on artificially weathered test specimen. The cut edges were completely smooth, none of the squares of the grid had chipped off.

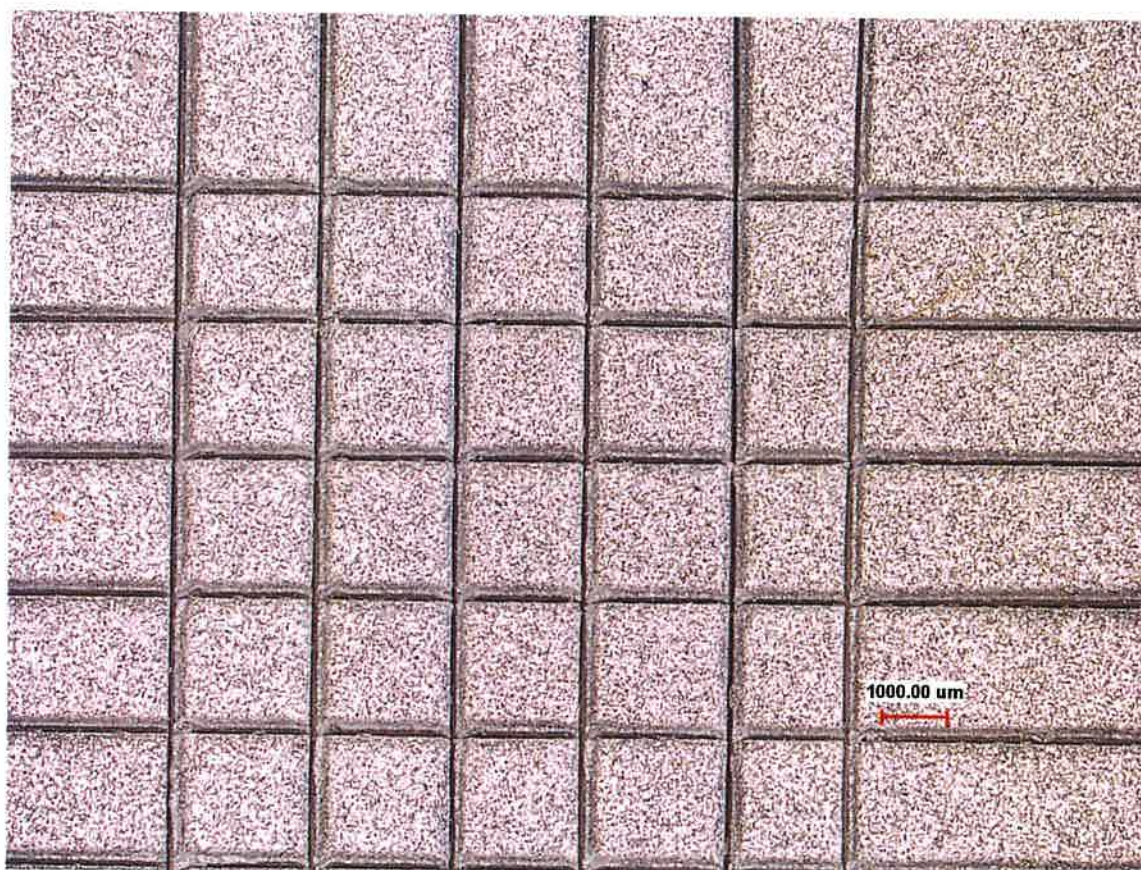
Detailed view 20x magnification after 8 GJ/m²

Cross-cut Grade		
Sample no. 5: Hydropur 2K 7515 / RAL 9006 + Hydropur Decklack 2K 7590		
before artificial weathering	after artificial weathering	
	4 GJ/m ²	8 GJ/m ²
Gt 0 (ISO 2409: 2013 – 1c – 0)	Gt 0 (ISO 2409: 2013 – 1c – 0)	Gt 0 (ISO 2409: 2013 – 1c – 0)
Cross-cut grade 0 was determined on zero sample (delivery condition) as well as on artificially weathered test specimen. The cut edges were completely smooth, none of the squares of the grid had chipped off.

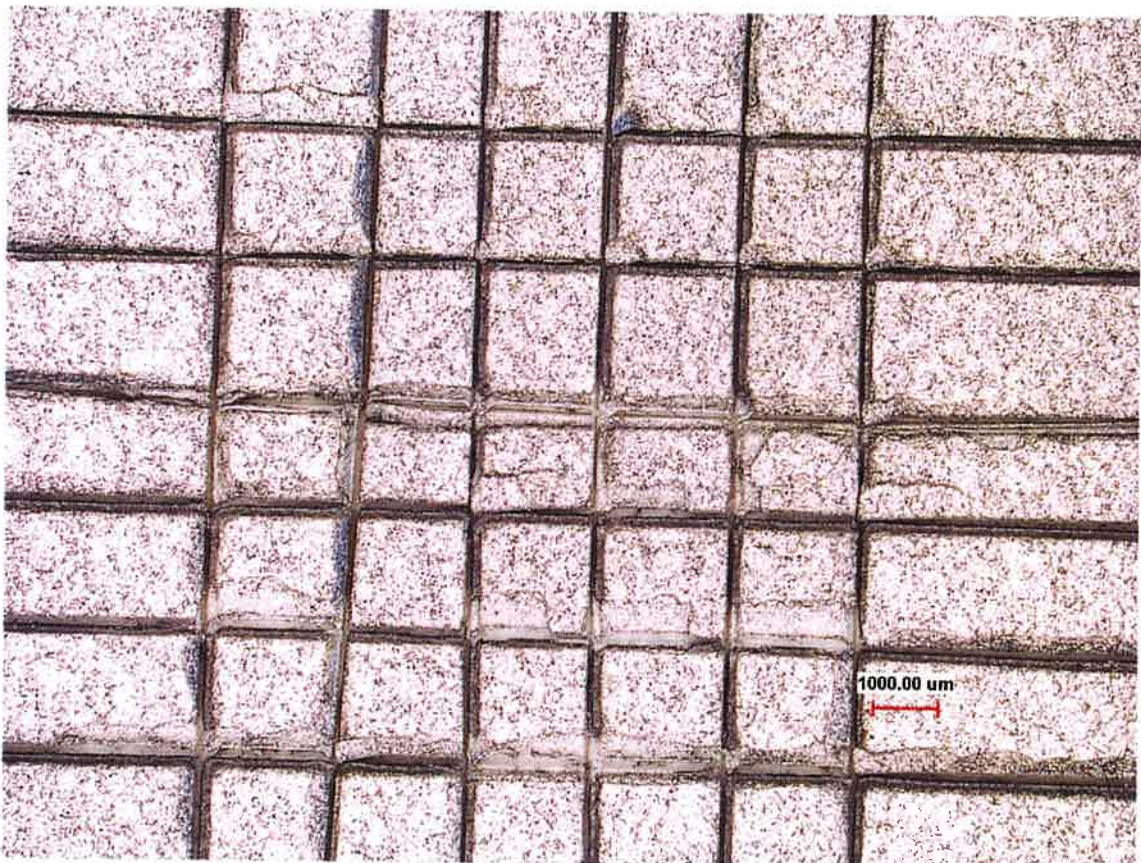
Detailed view 20x magnification after 8 GJ/m²

Cross-cut Grade		
Sample no. 6: Alpocryl LE / RAL 9006 + Alpocryl Klarlack 5454		
before artificial weathering	after artificial weathering	
	4 GJ/m ²	8 GJ/m ²
Gt 0 (ISO 2409: 2013 – 1c – 0)	Gt 0 (ISO 2409: 2013 – 1c – 0)	Gt 1 (ISO 2409: 2013 – 1c – 1)
<p>On zero sample (delivery condition) as well as on the sample artificially weathered with 4 GJ/m² cross-cut grade 0 was determined. The cut edges were completely smooth, none of the squares of the grid had chipped off.</p> <p>On the test specimen artificially weathered with 8 GJ/m², a cross-cut grade of 1 was determined on the coating. At the intersections of the grid lines, small splinters of the coating have flaked off.</p>

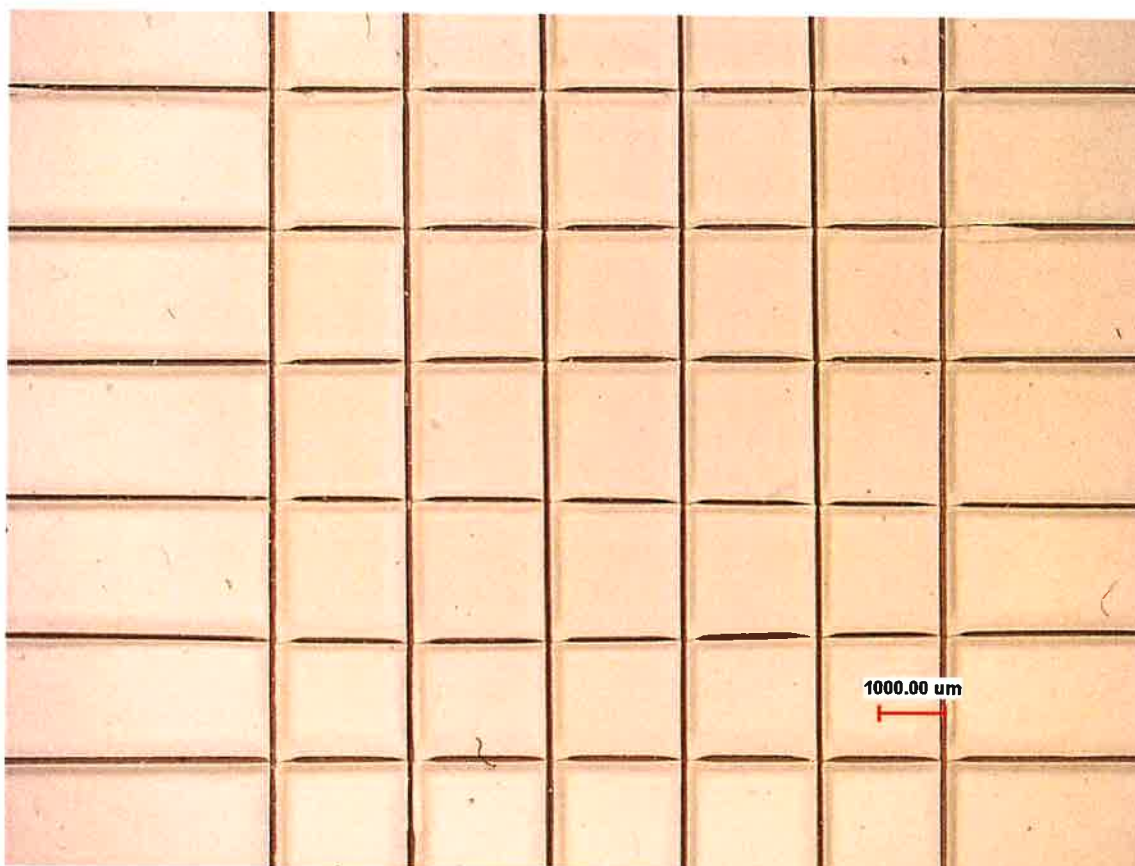
Detailed view 20x magnification after 8 GJ/m²

Cross-cut Grade		
Sample no. 7: Hydropur 2K 7515 / RAL 9001		
before artificial weathering	after artificial weathering	
	4 GJ/m ²	8 GJ/m ²
Gt 0 (ISO 2409: 2013 – 1c – 0)	Gt 0 (ISO 2409: 2013 – 1c – 0)	Gt 0 (ISO 2409: 2013 – 1c – 0)
Cross-cut grade 0 was determined on zero sample (delivery condition) as well as on artificially weathered test specimen. The cut edges were completely smooth, none of the squares of the grid had chipped off.

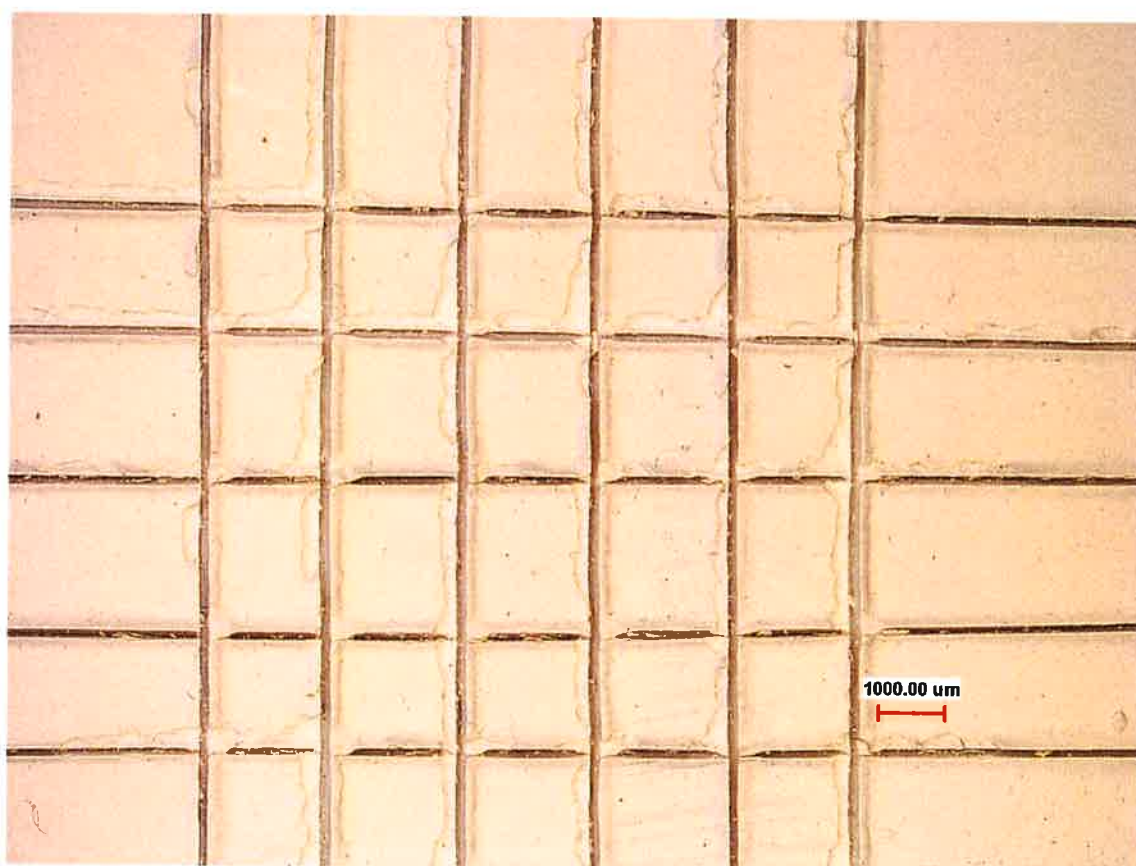
Detailed view 20x magnification after 8 GJ/m²

Cross-cut Grade		
Sample no. 8: Alpocryl LE / RAL 9001		
before artificial weathering	after artificial weathering	
	4 GJ/m ²	8 GJ/m ²
Gt 0 (ISO 2409: 2013 – 1c – 0)	Gt 0 (ISO 2409: 2013 – 1c – 0)	Gt 1 (ISO 2409: 2013 – 1c – 1)
<p>On zero sample (delivery condition) as well as on the sample artificially weathered with 4 GJ/m² cross-cut grade 0 was determined. The cut edges were completely smooth, none of the squares of the grid had chipped off.</p> <p>On the test specimen artificially weathered with 8 GJ/m², a cross-cut grade of 1 was determined on the coating. At the intersections of the grid lines, small splinters of the coating have flaked off.</p>

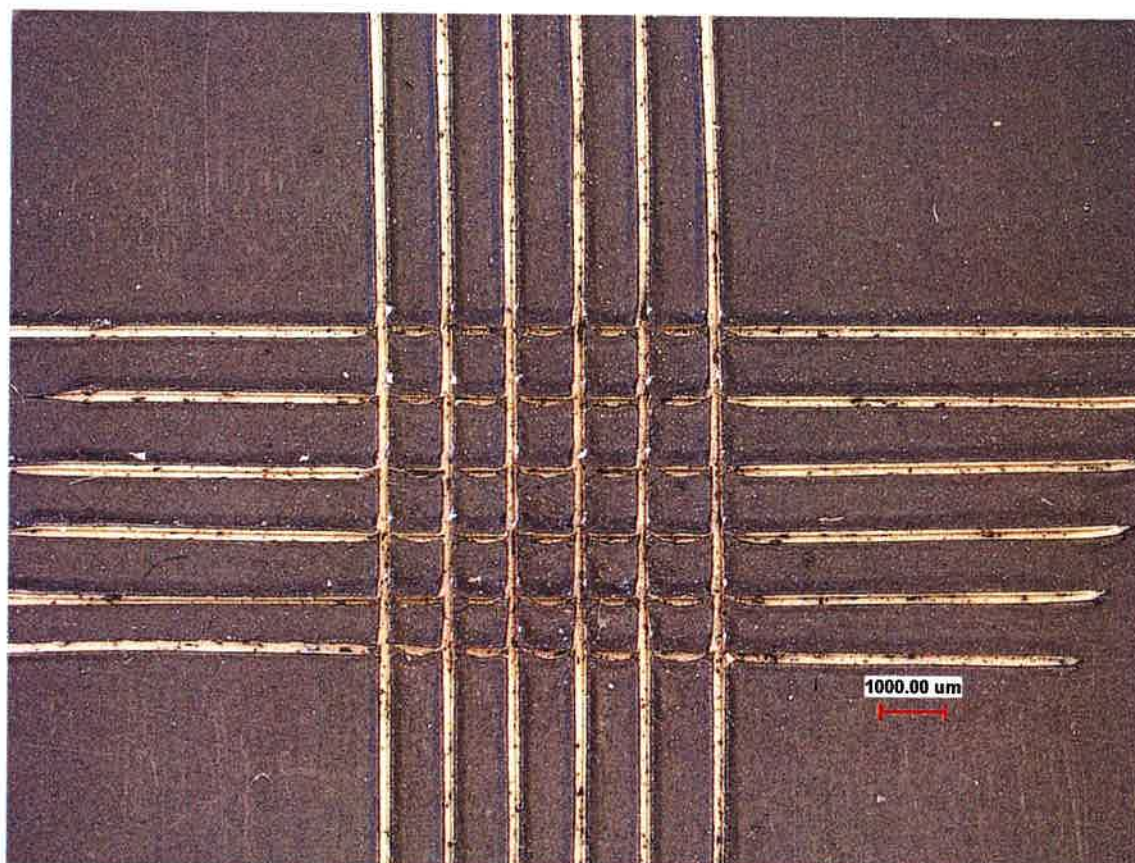
Detailed view 20x magnification after 8 GJ/m²

Cross-cut Grade		
Sample no. 9: Alpocryl LE / RAL 7016		
before artificial weathering	after artificial weathering	
	4 GJ/m ²	8 GJ/m ²
Gt 0 (ISO 2409: 2013 – 1c – 0)	Gt 0 (ISO 2409: 2013 – 1c – 0)	Gt 0 (ISO 2409: 2013 – 1c – 0)
Cross-cut grade 0 was determined on zero sample (delivery condition) as well as on artificially weathered test specimen. The cut edges were completely smooth, none of the squares of the grid had chipped off.

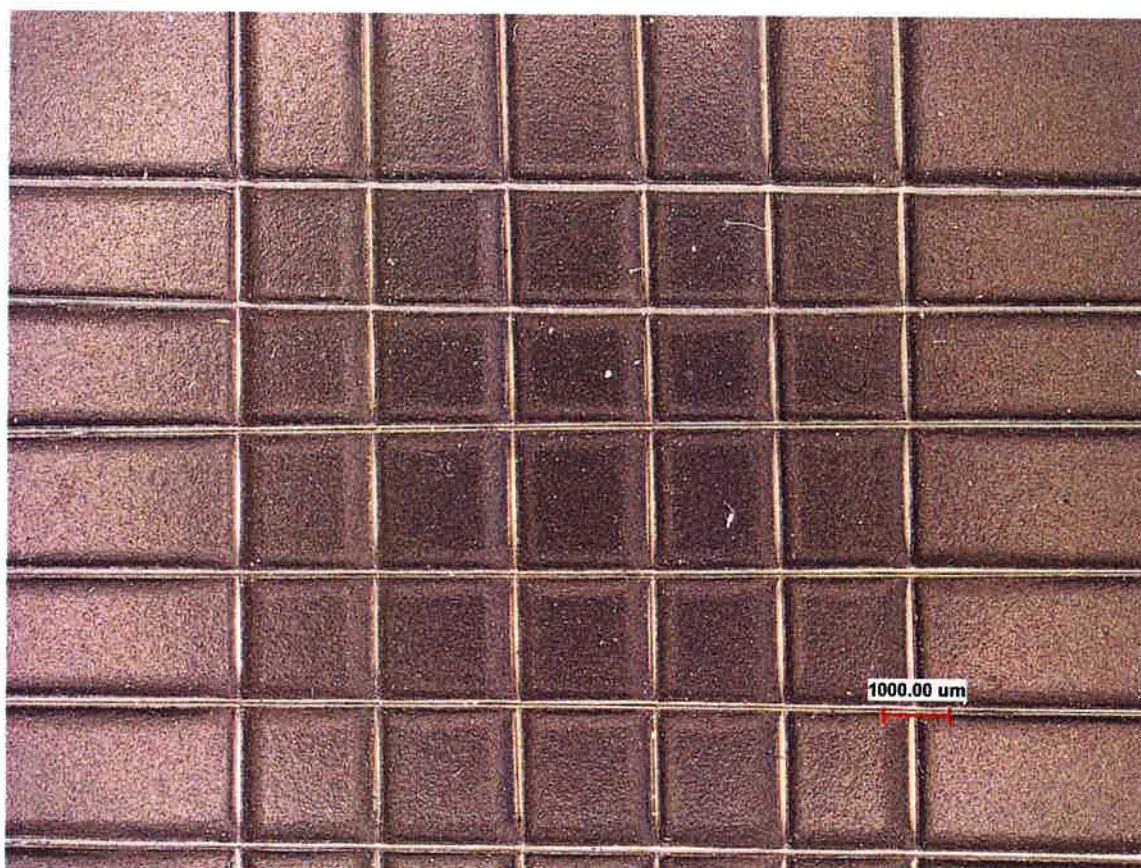
Detailed view 20x magnification after 8 GJ/m²

Cross-cut Grade		
Sample no. 10: Hydropur 2K 7515 / RAL 7016		
before artificial weathering	after artificial weathering	
	4 GJ/m ²	8 GJ/m ²
Gt 0 (ISO 2409: 2013 – 1c – 0)	Gt 0 (ISO 2409: 2013 – 1c – 0)	Gt 0 (ISO 2409: 2013 – 1c – 0)
Cross-cut grade 0 was determined on zero sample (delivery condition) as well as on artificially weathered test specimen. The cut edges were completely smooth, none of the squares of the grid had chipped off.
